# EXTERIOR WALL REPAIRS

JOLIET JUNIOR COLLEGE  
BUILDINGS A,C,D,E,G  
1215 HOUBOLT ROAD  
JOLIET, ILLINOIS

DATE:  
3/10/2023  
REVISED:

PROJECT NO.  
2302-01

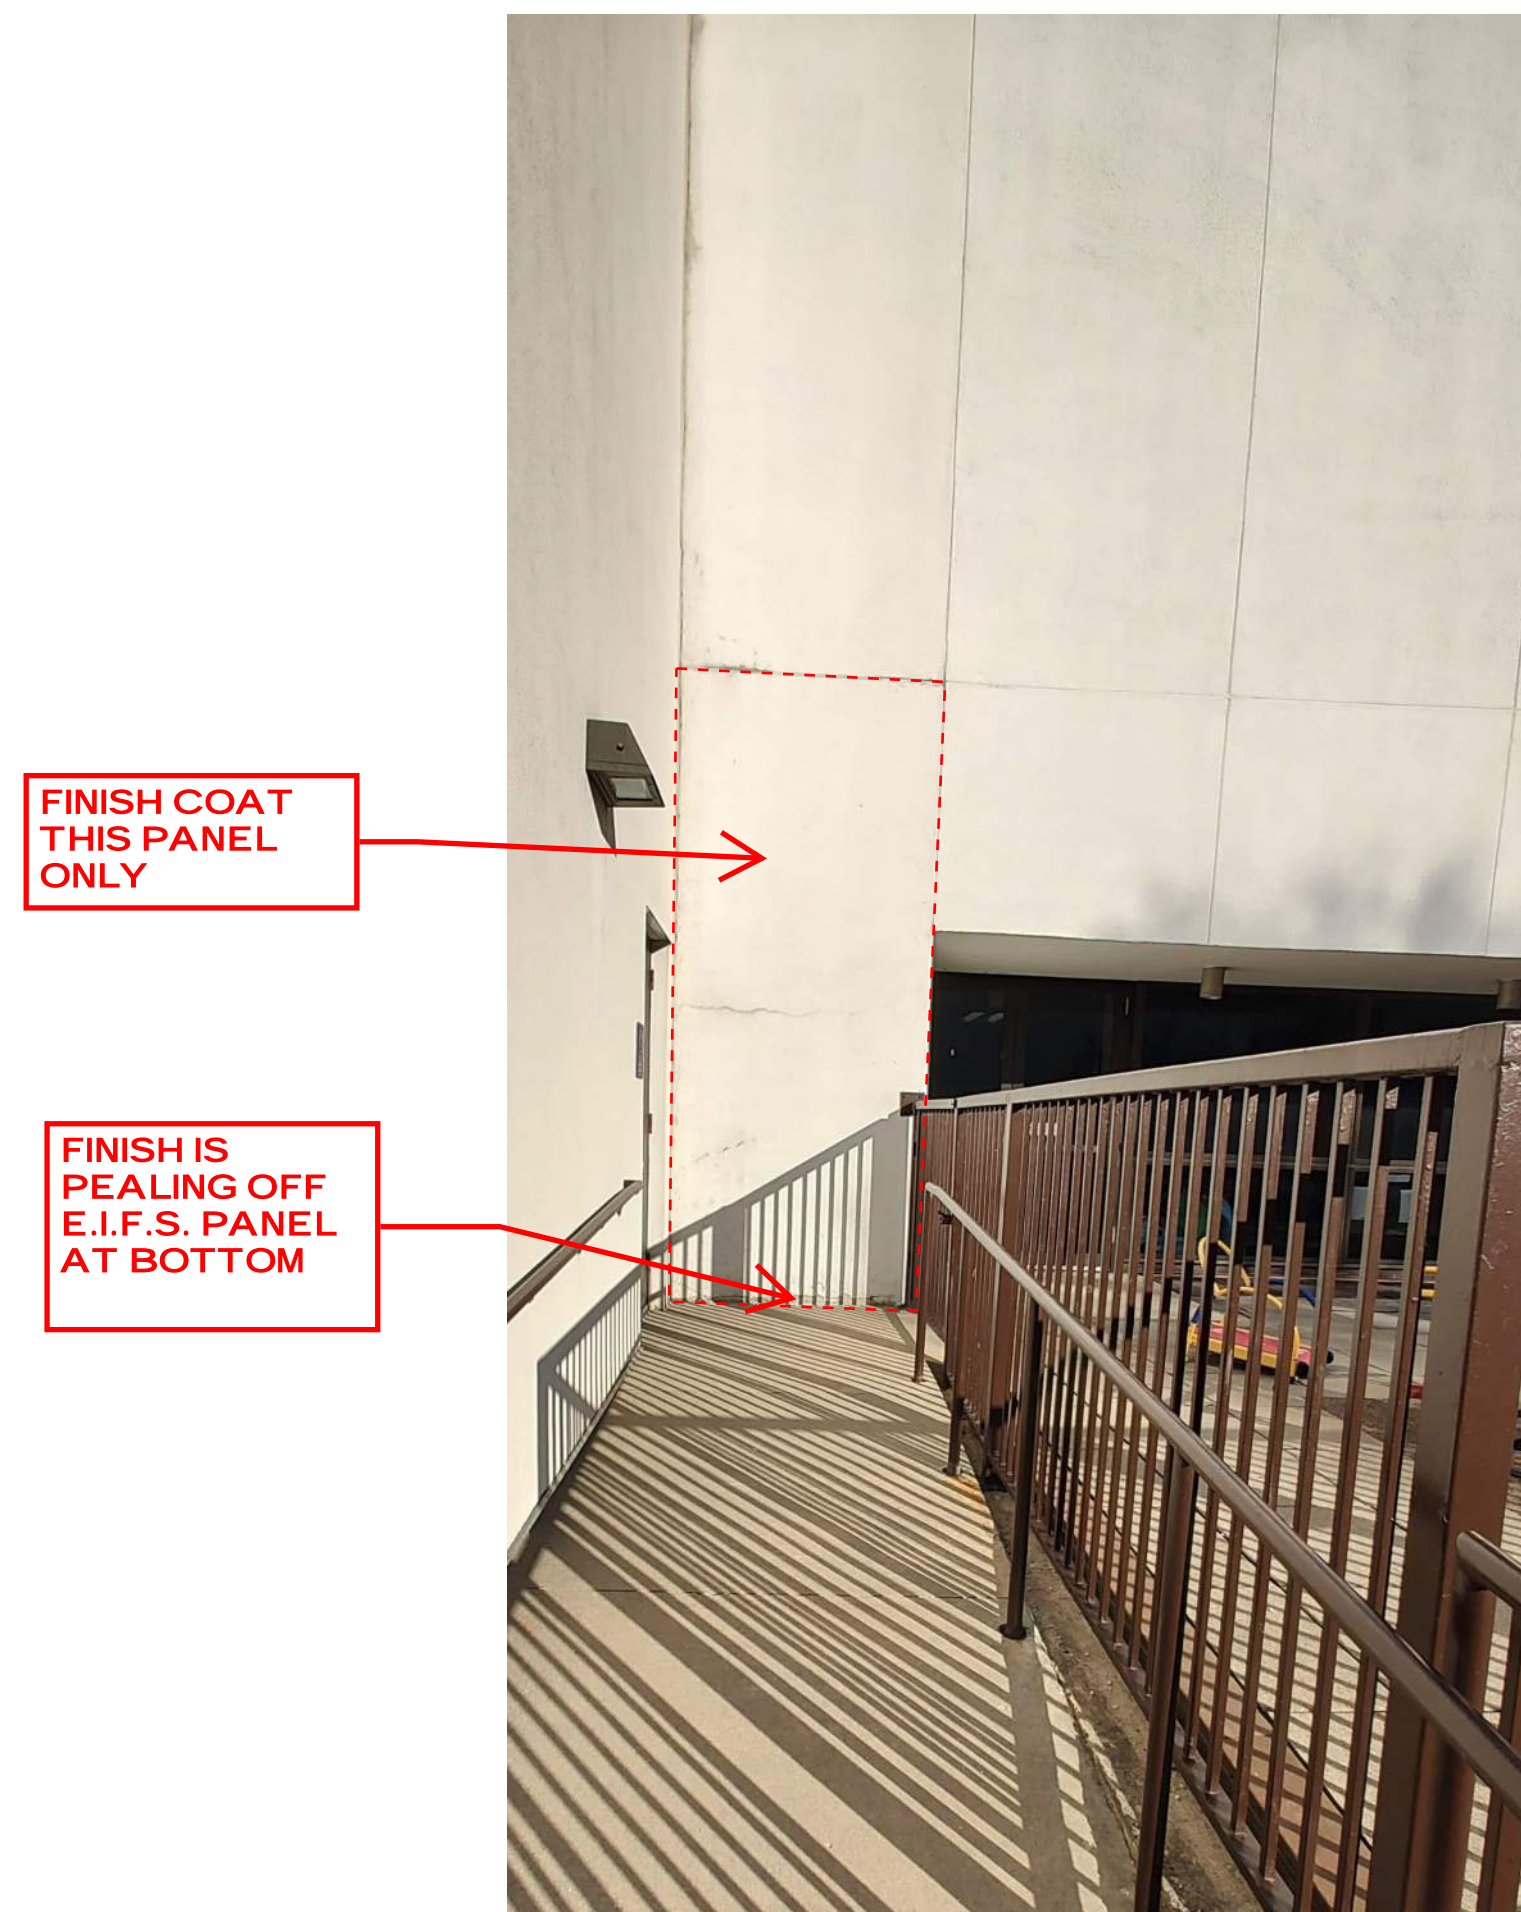
A BUILDING C

STUCCO  
FINISH IS  
PEALING OFF  
CMU  
SUBSTRATE  
AT BASE OF  
WALL BOTH  
SIDES OF  
DOOR  
ALCOVE.

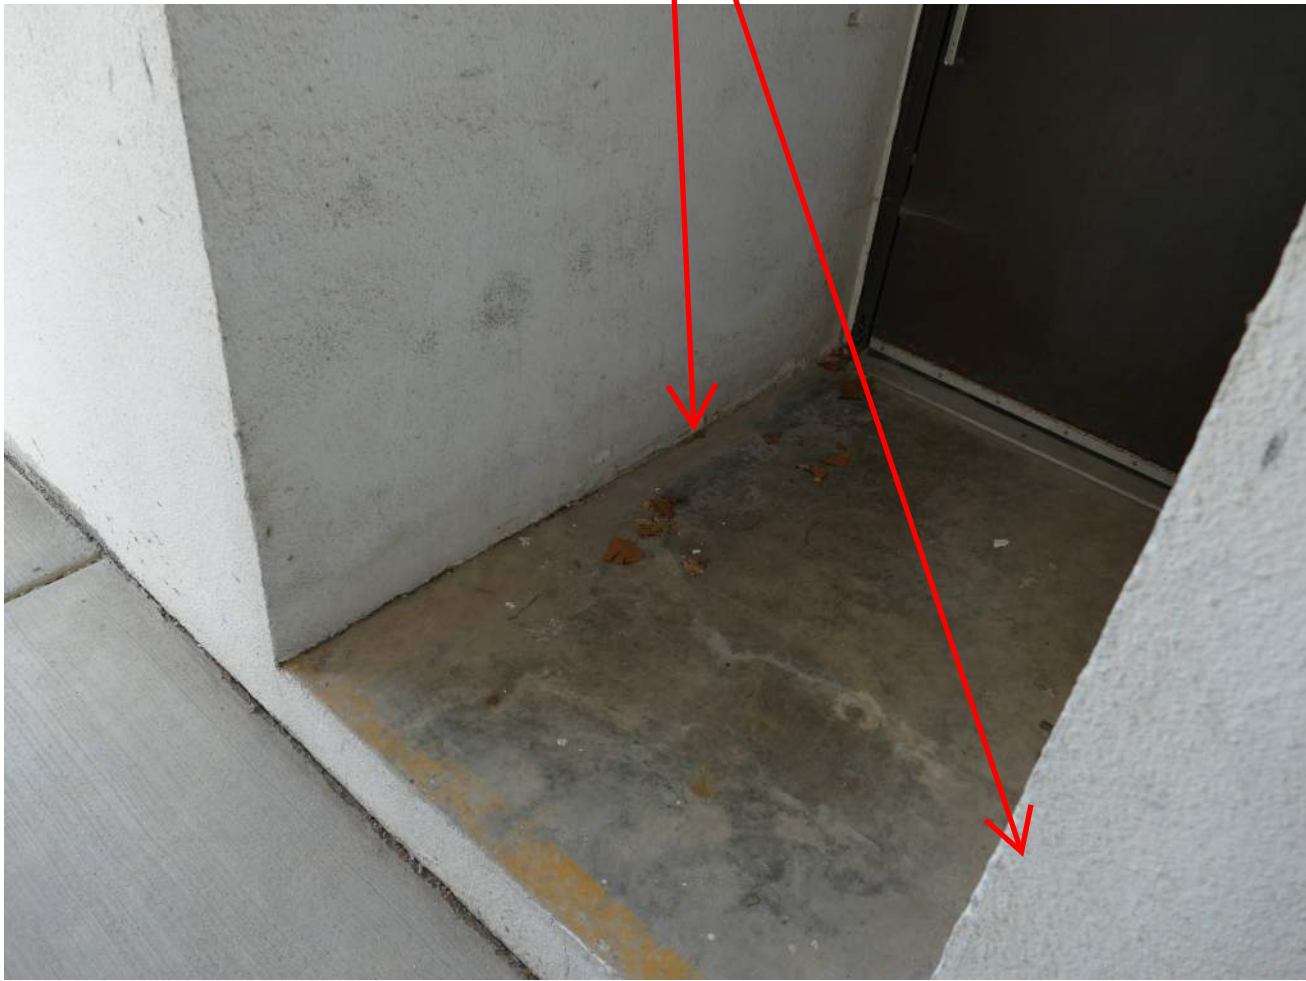
**E** BUILDING E

STUCCO  
FINISH IS  
PEALING OFF  
CMU  
SUBSTRATE  
AT BASE OF  
WALL BOTH  
SIDES OF  
DOOR  
ALCOVE.

AFTER  
REPAIRS  
PROVIDE NEW  
FINISH ON ALL  
WALLS FULL  
HEIGHT FROM  
CORNER TO  
CORNER AT  
AREA  
INDICATED.

FINISH COAT  
TO CONTINUE  
ON CEILING OF  
DOOR  
RECESS

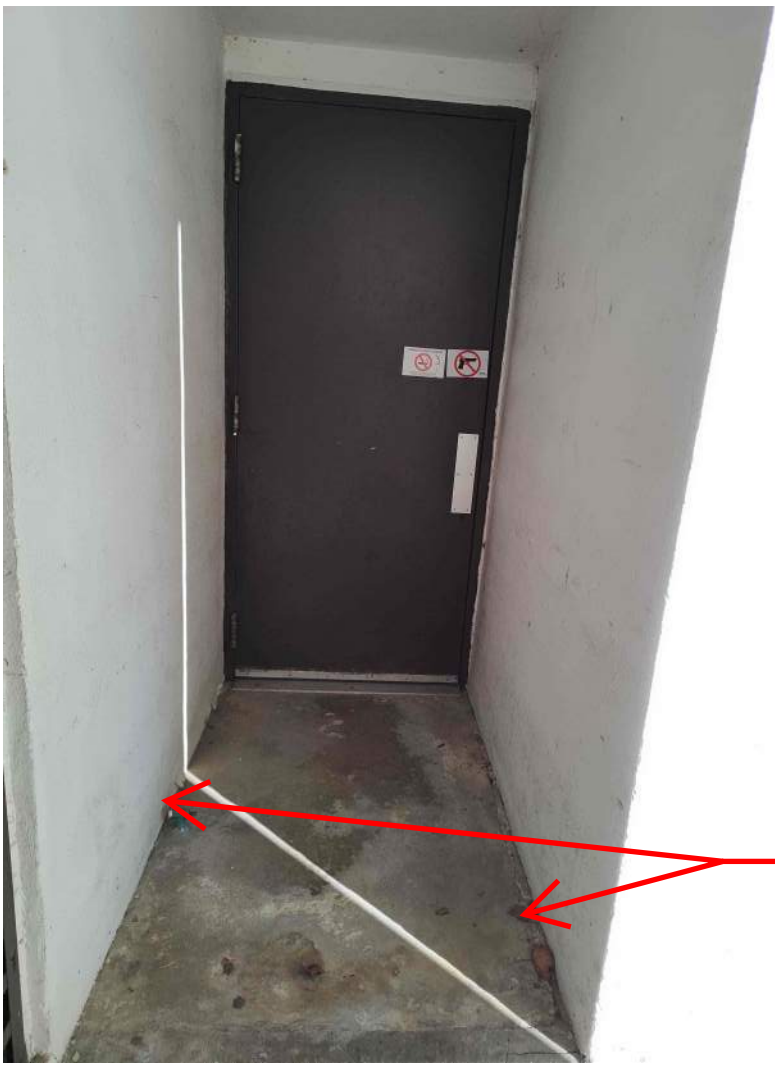
**C** BUILDING C

CRACKS IN  
STUCCO  
FINISH ON CMU  
MULTIPLE  
LOCATIONS  
ON THIS WALL

AREA WHERE  
STUCCO  
FINISH IS  
PEALING AND  
BUBBLING OFF  
EXISTING CMU

EXISTING E.I.F.S  
APPEAR IN GOOD  
CONDITION.  
CONTINUE NEW  
FINISH COAT  
OVER THIS  
SURFACE UP TO  
COPING CAP

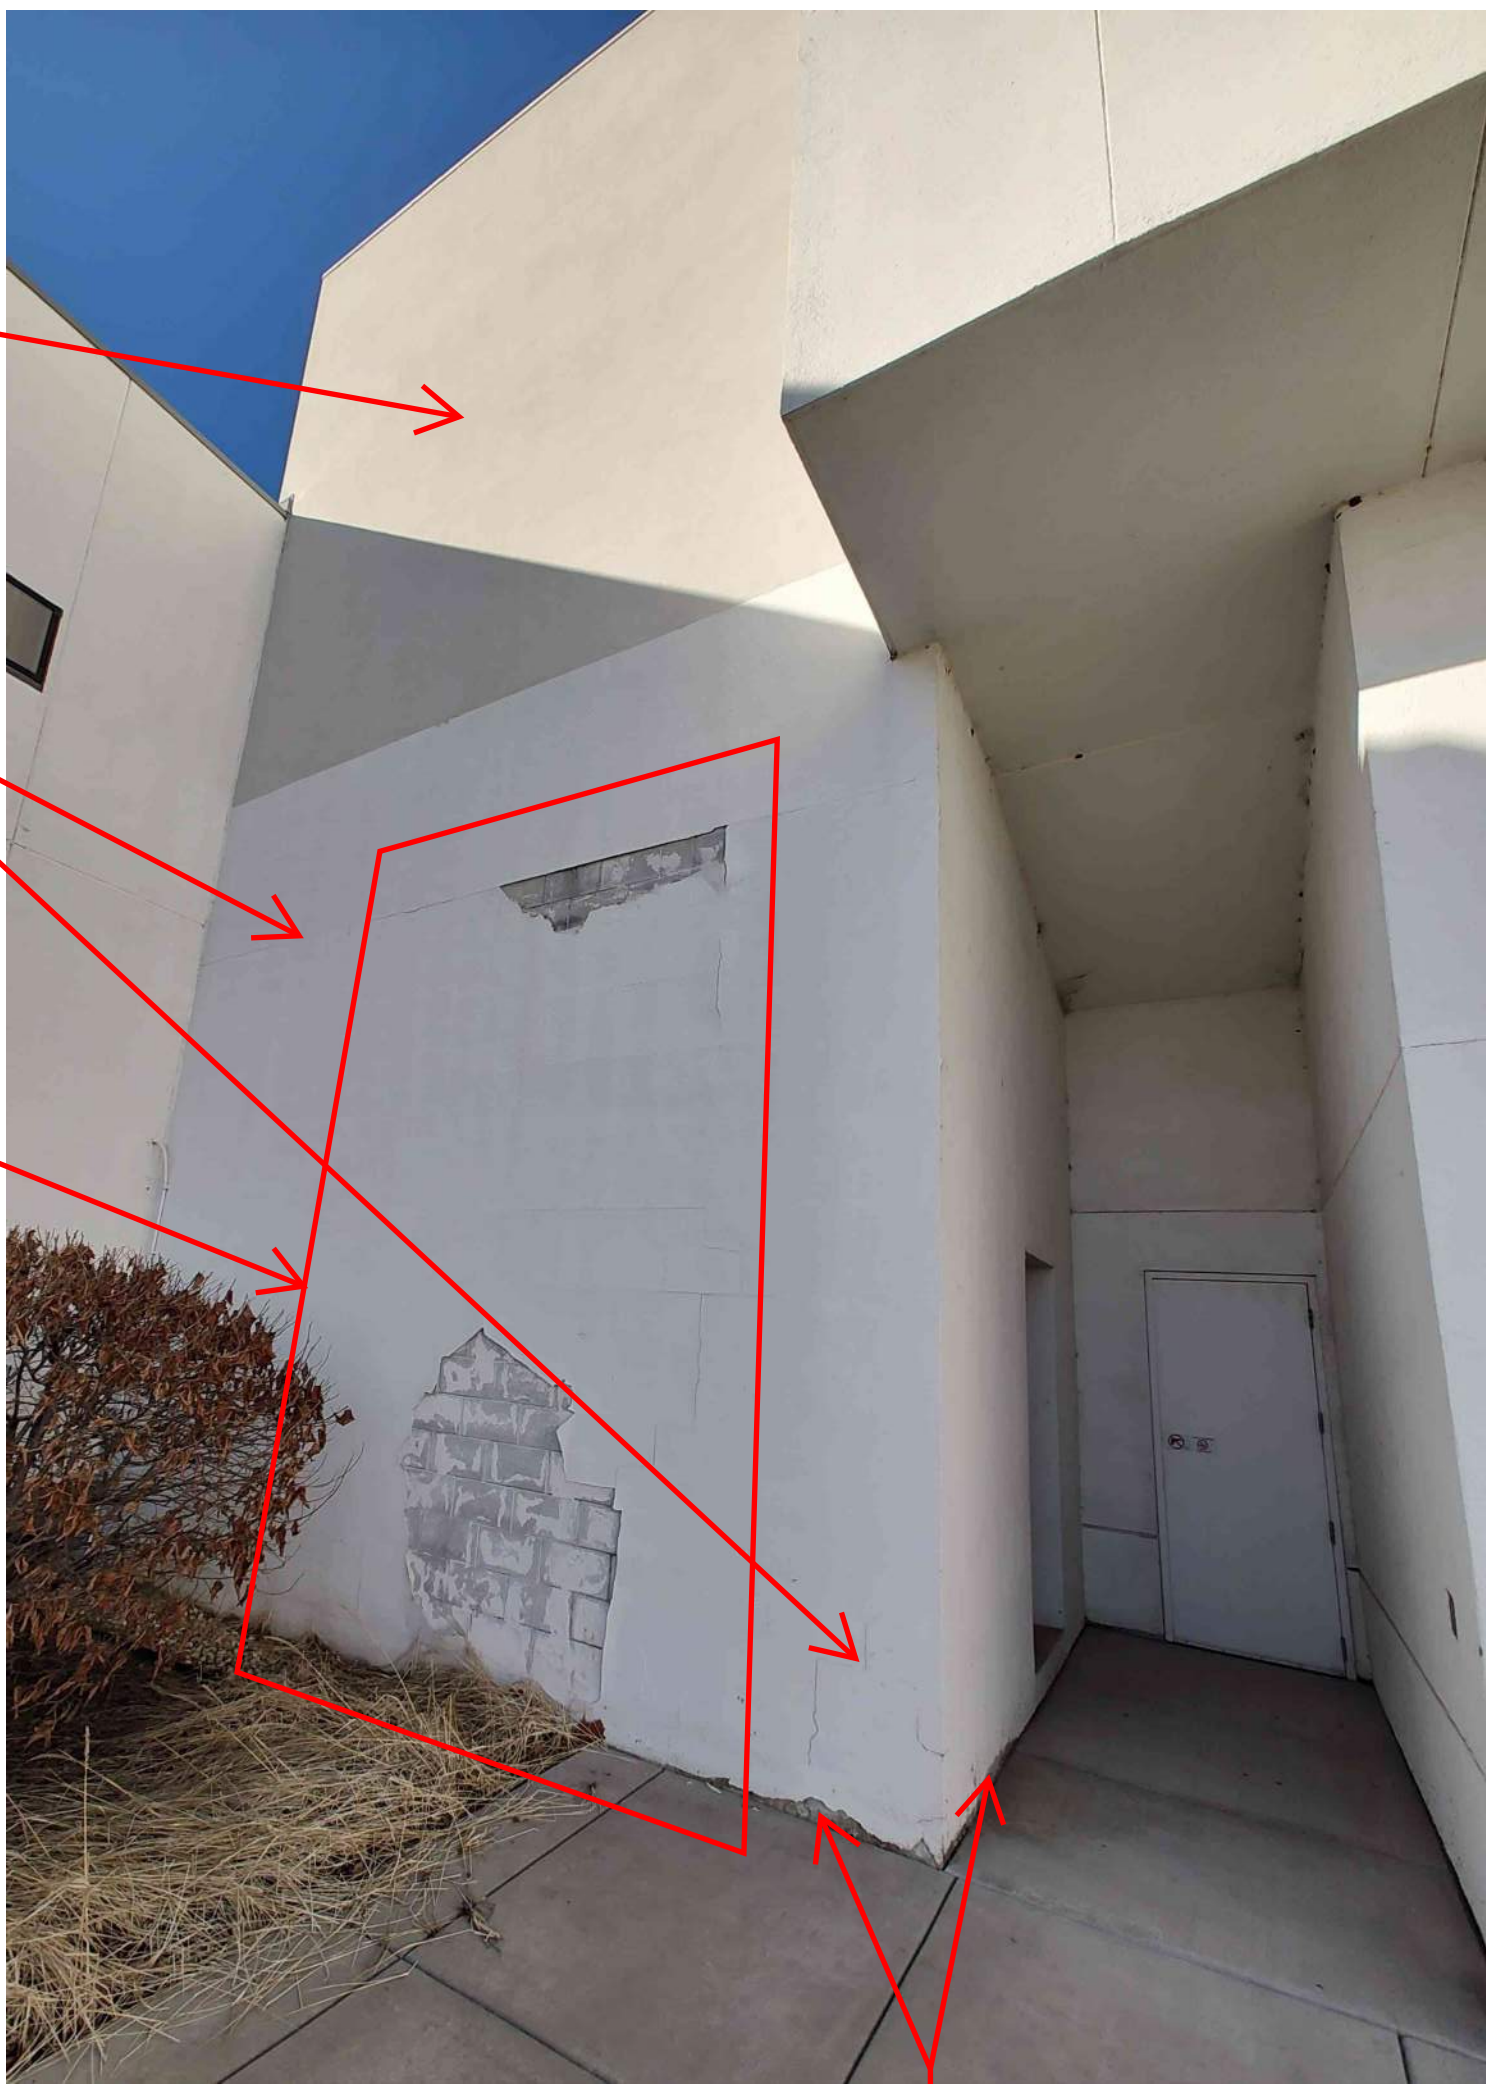
**D** BUILDING E

STUCCO  
FINISH IS  
PEALING OFF  
CMU  
SUBSTRATE  
AT BASE OF  
WALL.

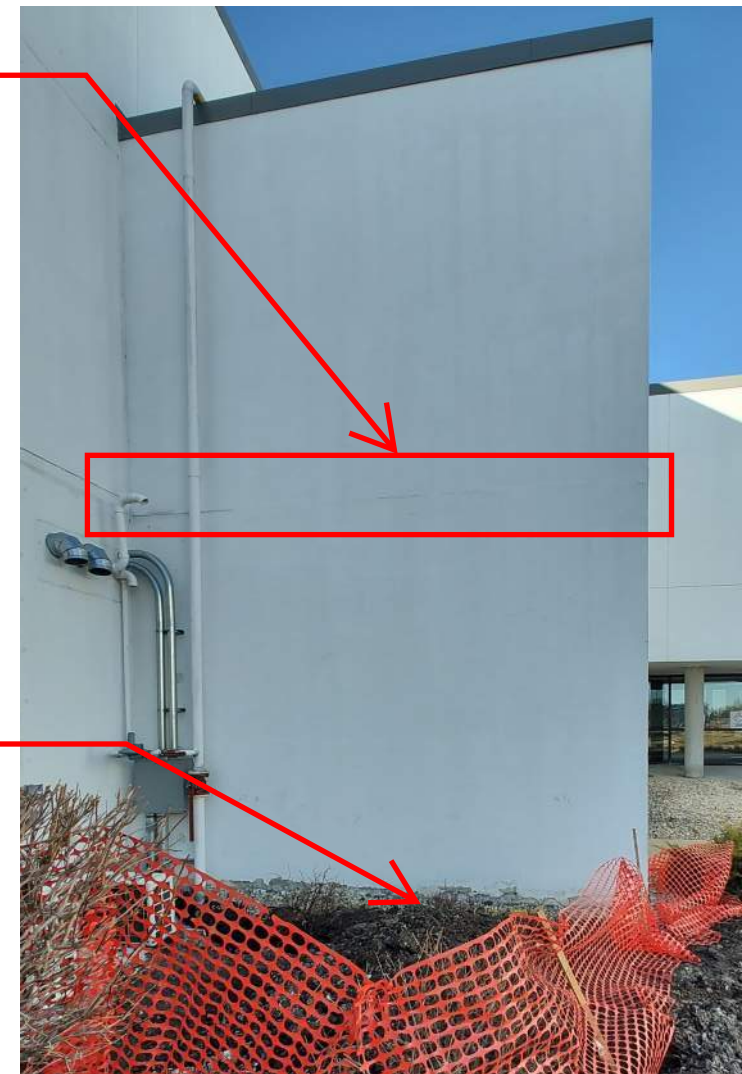
I BUILDING G

CRACKS IN STUCCO FINISH ON CMU MULTIPLE LOCATIONS ON THIS WALL

STUCCO FINISH IS PEELING OFF CMU SUBSTRATE AT BASE OF WALL

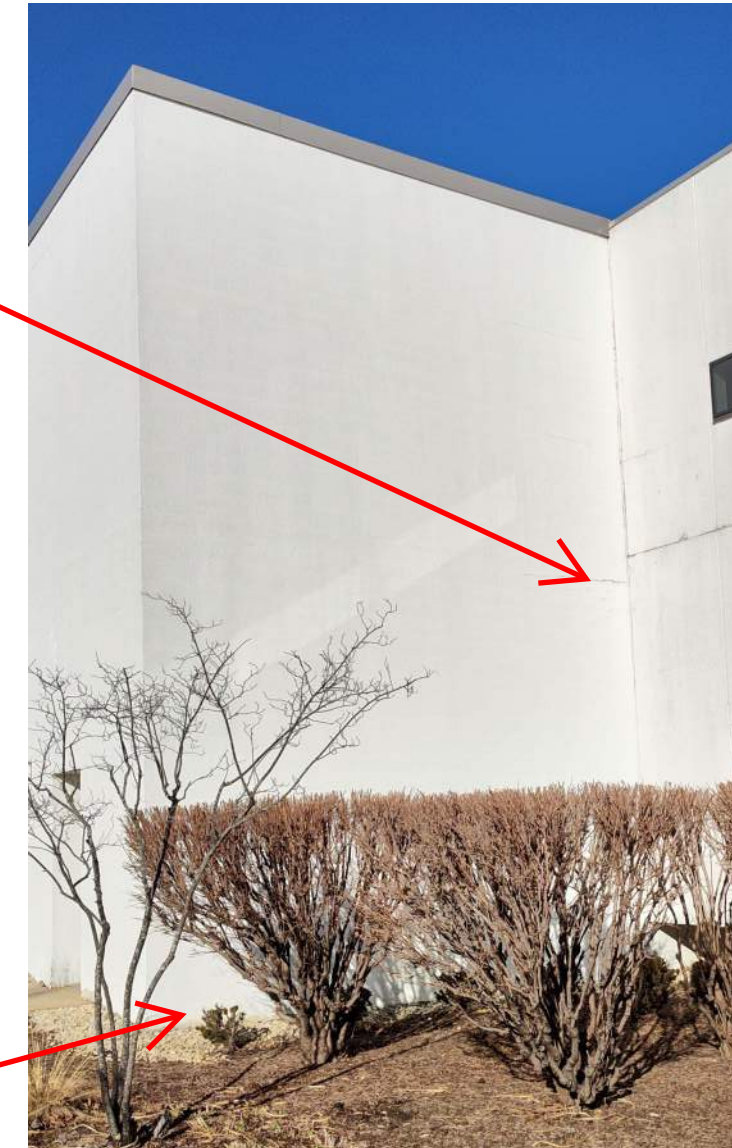
F BUILDING E

CRACKS IN STUCCO FINISH ON CMU MULTIPLE LOCATIONS ON THIS WALL

STUCCO FINISH IS PEELING OFF CMU SUBSTRATE AT BASE OF WALL.

FINISH COAT TO CONTINUE ON CEILING OF DOOR RECESS

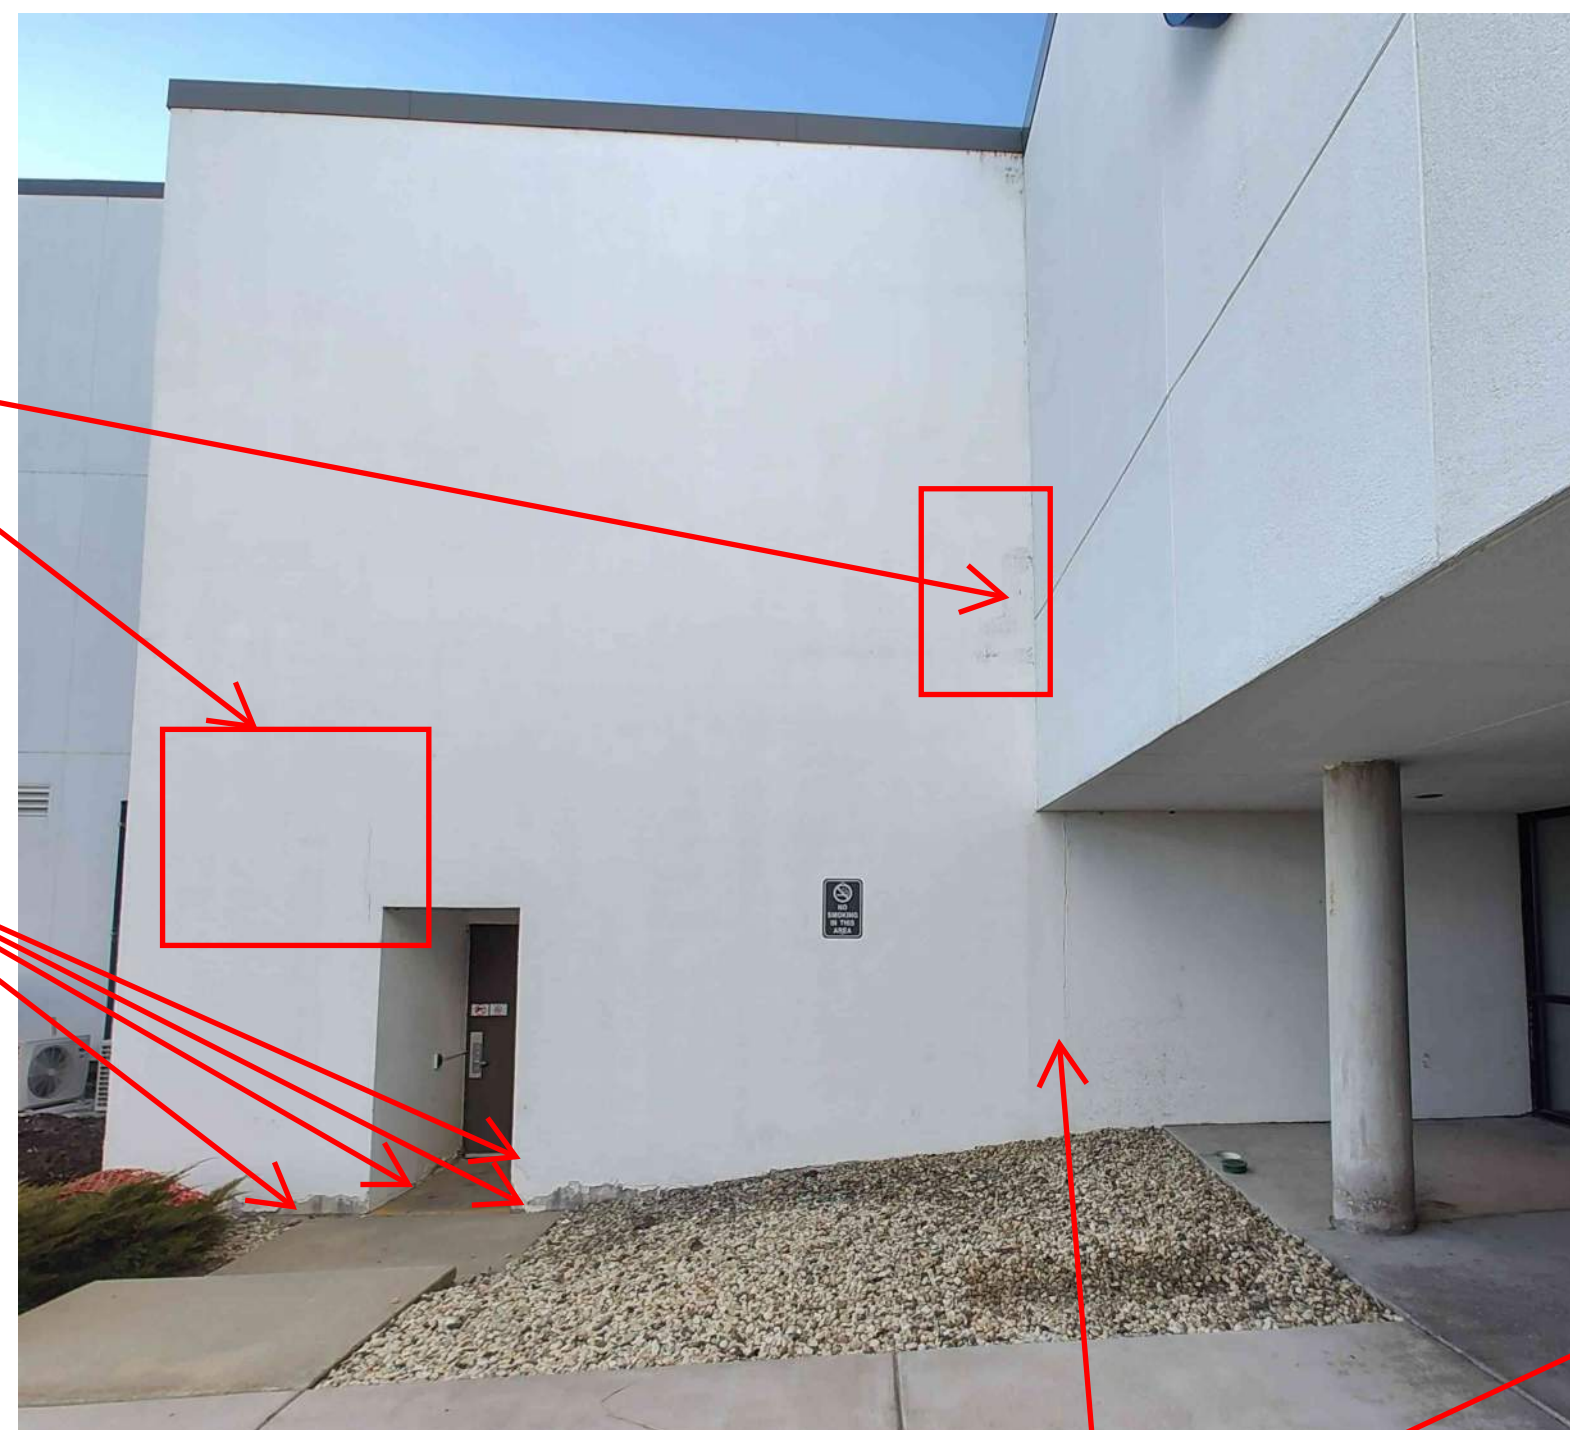
H BUILDING G

CRACKS IN STUCCO FINISH ON CMU MULTIPLE LOCATIONS ON THIS WALL

STUCCO FINISH IS PEELING OFF CMU SUBSTRATE AT BASE OF WALL AND BASE OF SIDE WALL IN DOOR ALCOVE.

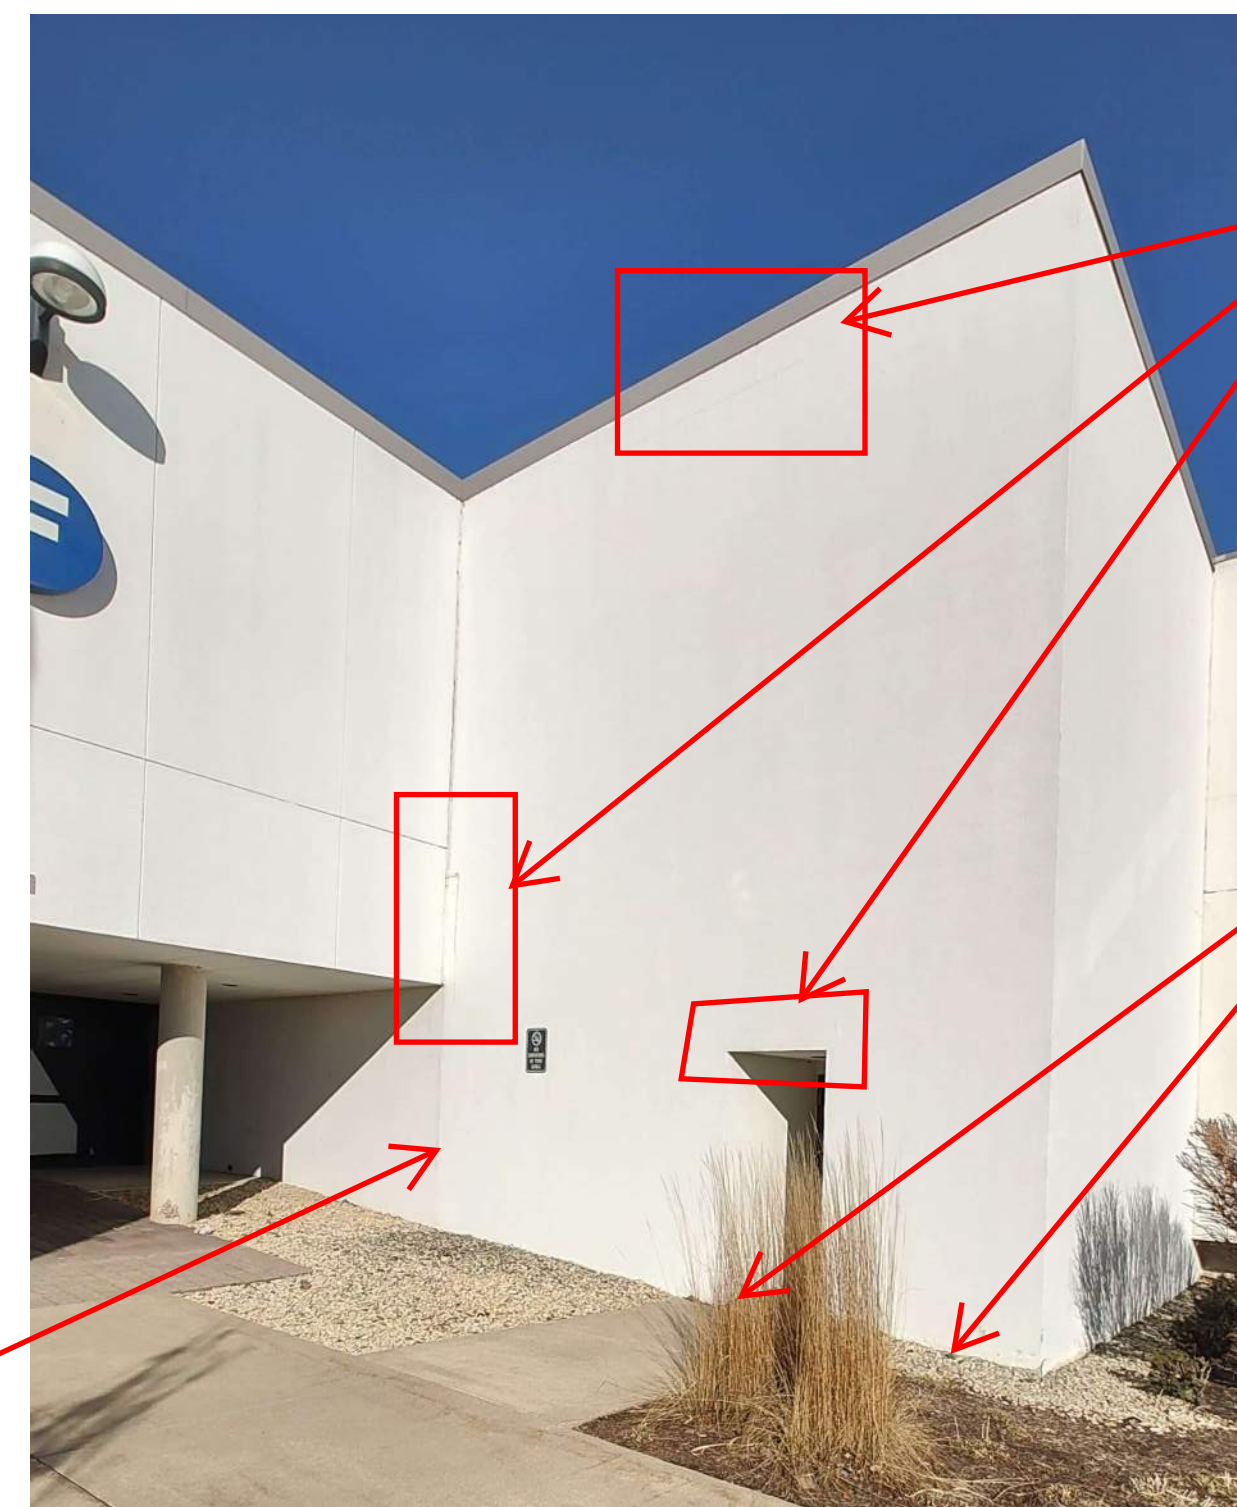
G BUILDING E

CRACKS IN STUCCO FINISH ON CMU MULTIPLE LOCATIONS ON THIS WALL

STUCCO FINISH IS PEELING OFF CMU SUBSTRATE AT BASE OF WALL AND BASE OF SIDE WALL IN DOOR ALCOVE.

REPAIR CRACKED SEALANT JOINT

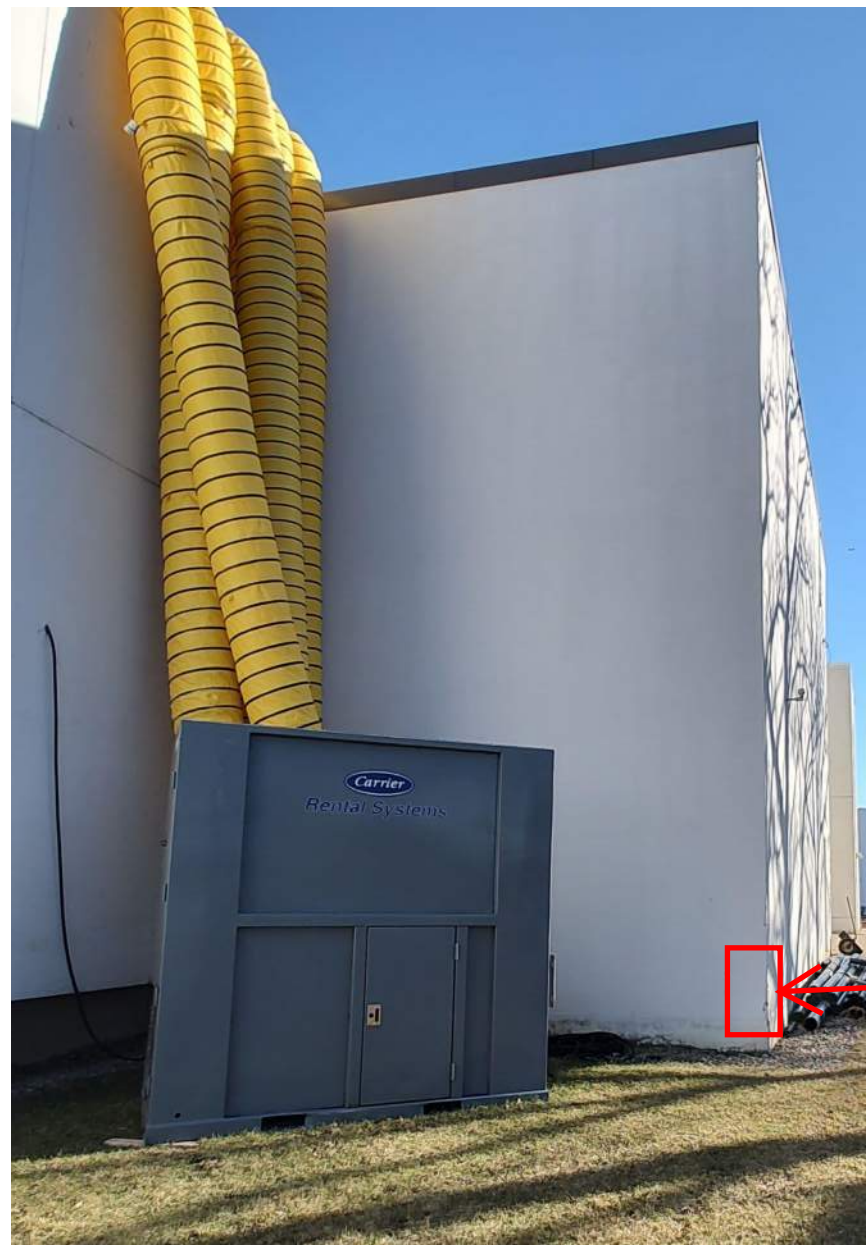
**L BUILDING G**

STUCCO FINISH IS PEELING OFF CMU SUBSTRATE AT CORNER

AFTER REPAIRS PROVIDE NEW FINISH ON ALL WALLS FULL HEIGHT FROM CORNER TO CORNER AT AREA INDICATED.

FINISH COAT TO CONTINUE ON CEILING OF DOOR RECESS

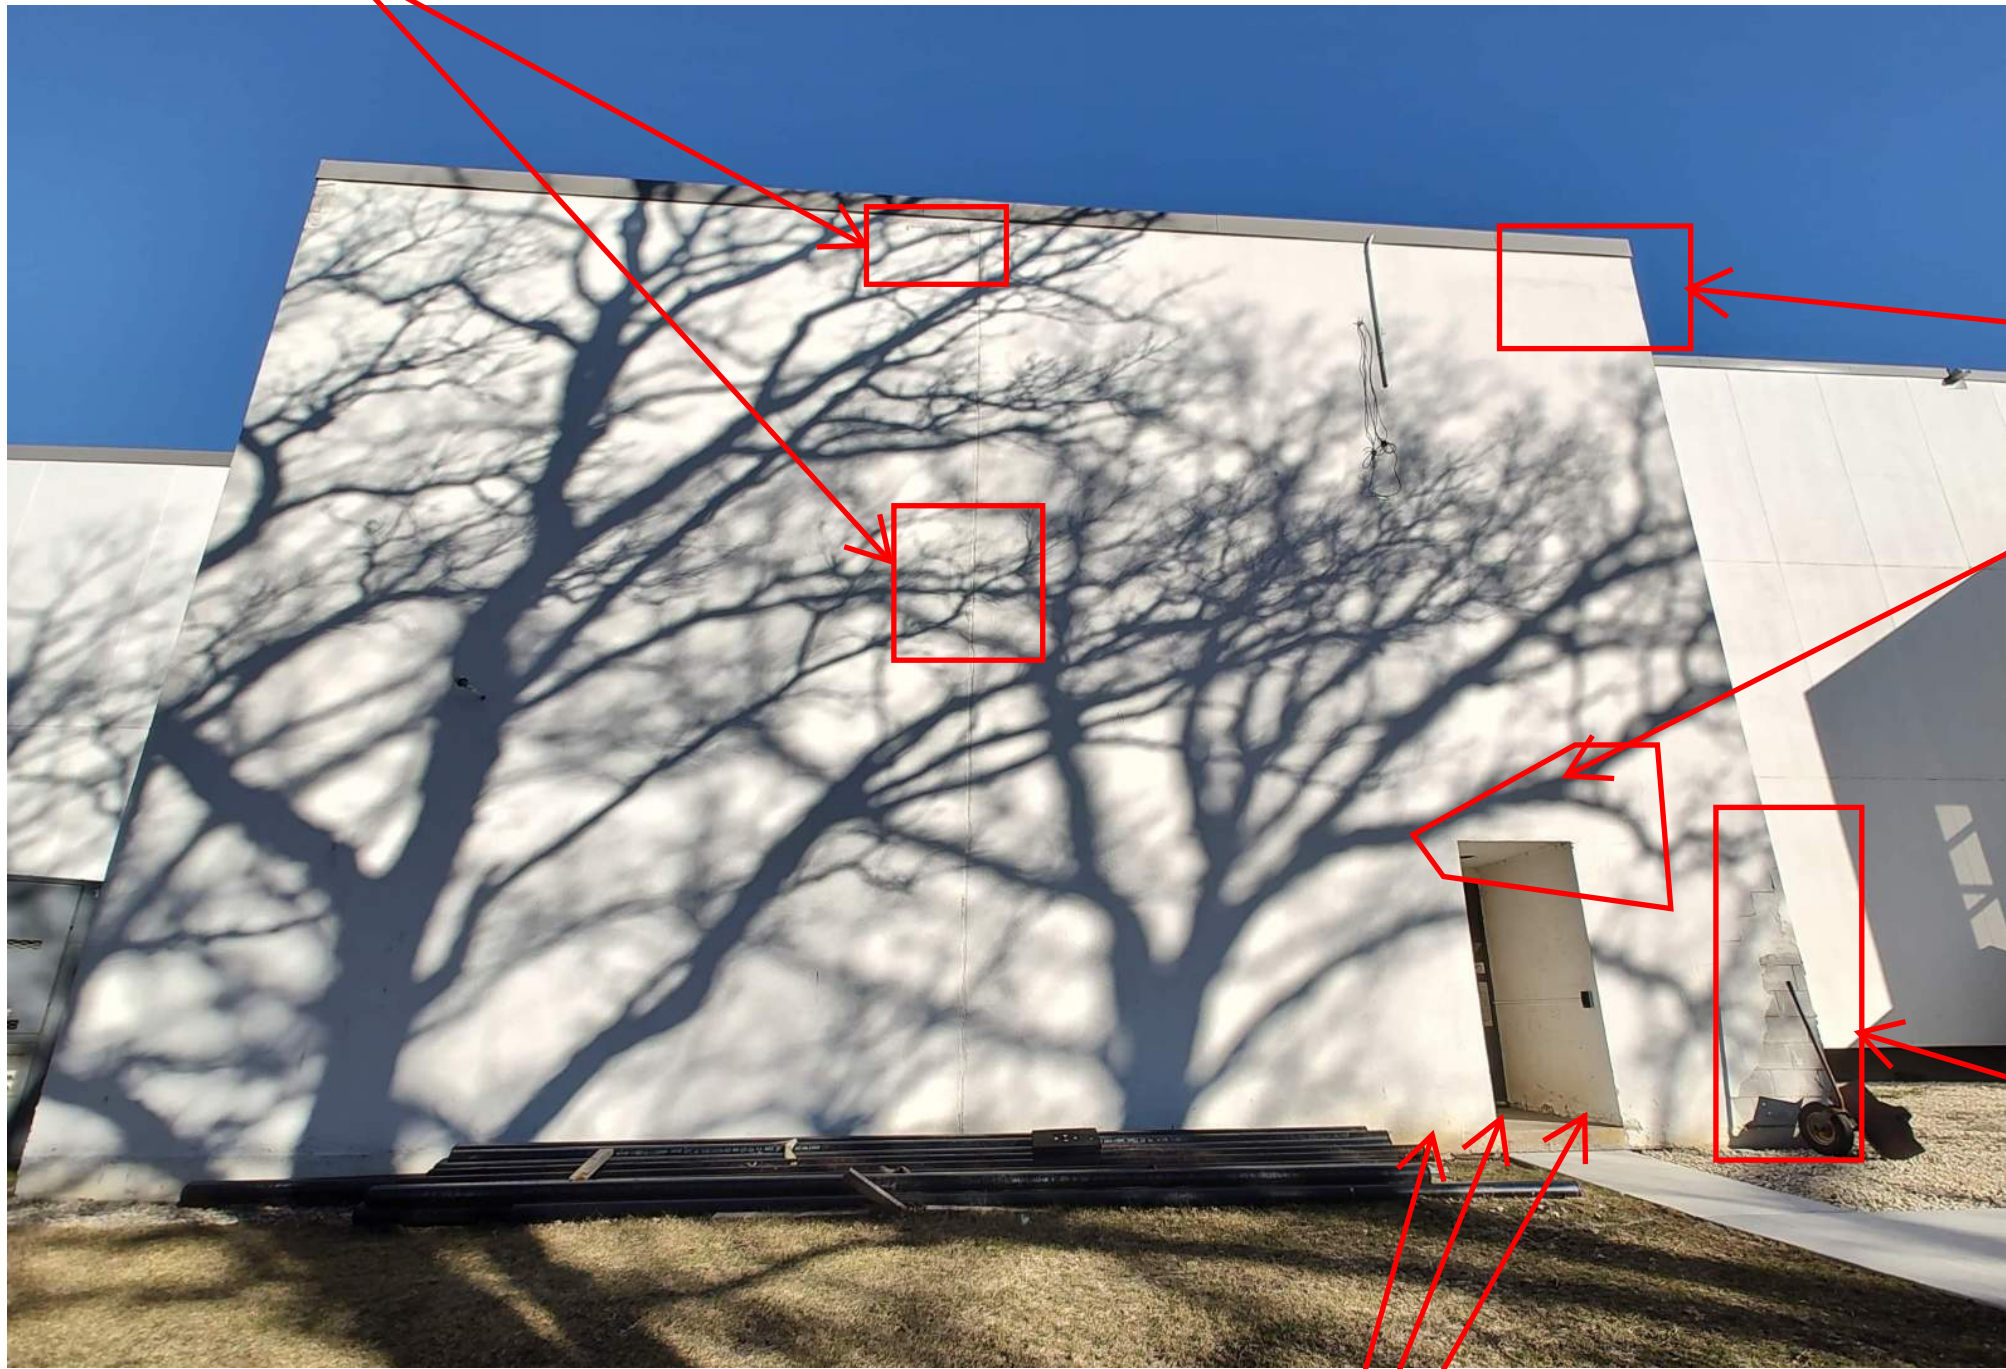
**K BUILDING G**

STUCCO FINISH IS PEELING OFF CMU SUBSTRATE AT BASE OF WALL AND BASE OF SIDE WALL IN DOOR ALCOVE.

CRACKS IN STUCCO FINISH ON CMU MULTIPLE LOCATIONS ON THIS WALL

AREA WHERE STUCCO FINISH IS PEELING AND BUBBLING OFF EXISTING CMU
