EXTERIOR FACADE REPAIRS 2024

JOLIET JUNIOR COLLEGE
BUILDINGS A
1215 HOUBOLT ROAD
JOLIET, ILLINOIS

PROJECT NO. 2310-02

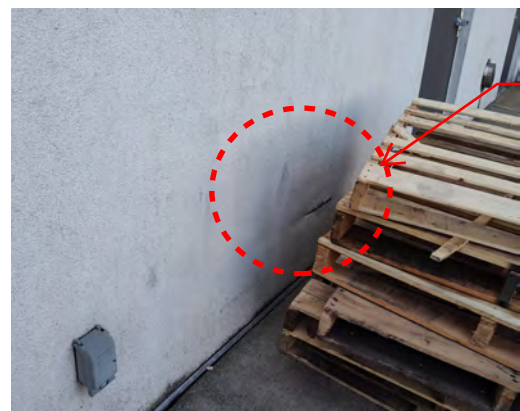
E.I.F.S IS DAMAGED AND DENTED.

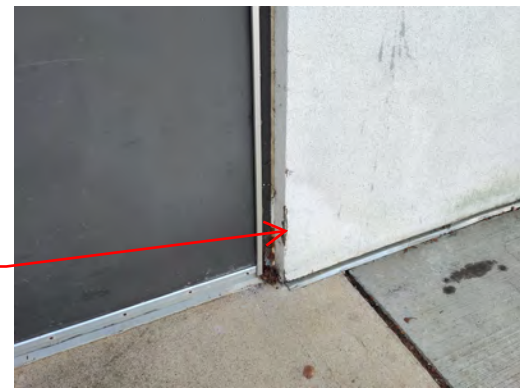
Picture "IL"

E.I.F.S BOTTOM EDGE IS DAMAGED

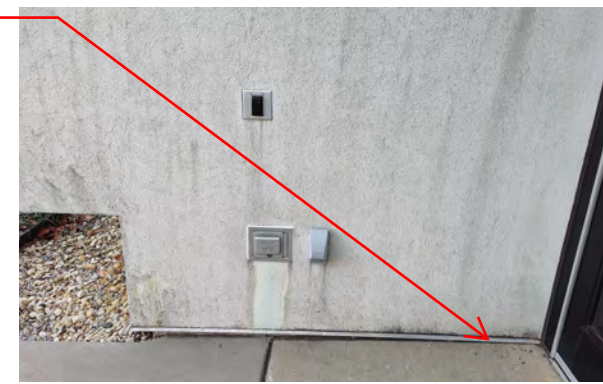
Picture "IN"

E.I.F.S. FINISH IS DAMAGED BACK TO INSULATION AT LOCATION OF ROOF OVERFLOW DRAIN

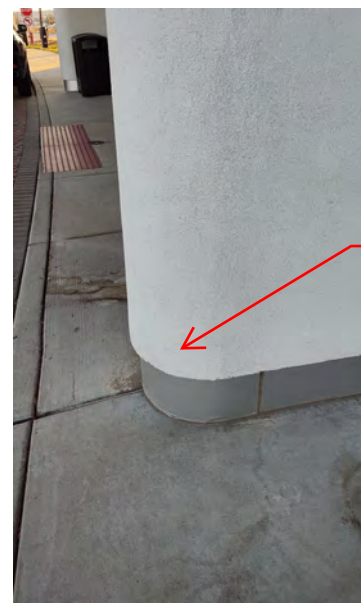
Picture "IR"

E.I.F.S FINISH IS DAMAGED AND DENTED

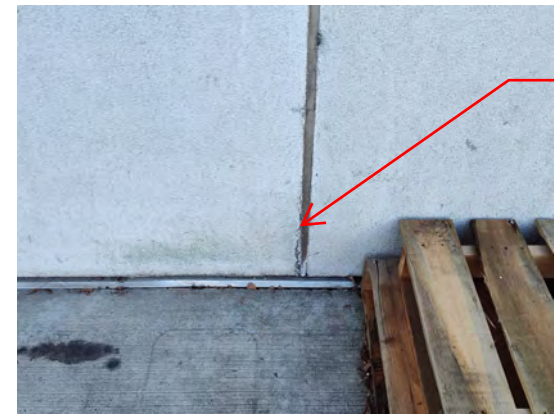
E.I.F.S FINISH IS CRACKED AT EXPANSION JOINT

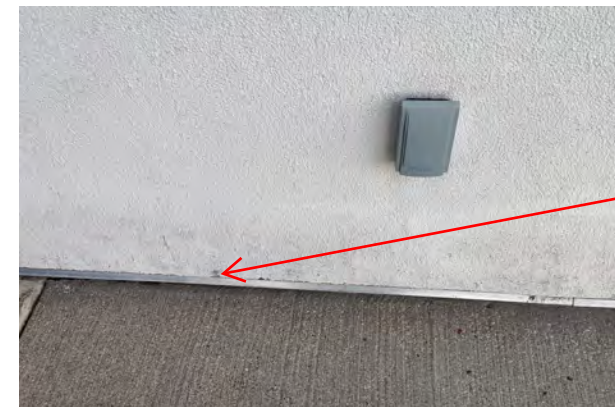
Picture "IO"

E.I.F.S BOTTOM EDGE IS DAMAGED

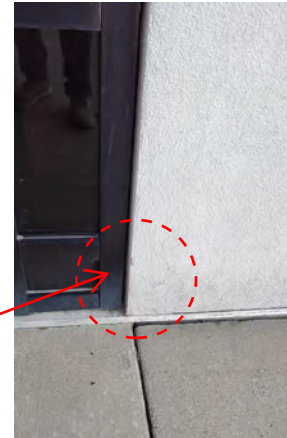
Picture "IQ"

BOTTOM EDGE OF E.I.F.S IS DAMAGED

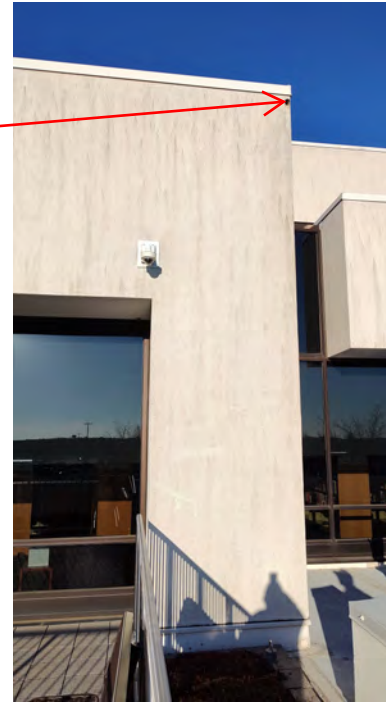
Picture "2C"

E.I.F.S FINISH IS DAMAGED WITH +/- 3" HOLE

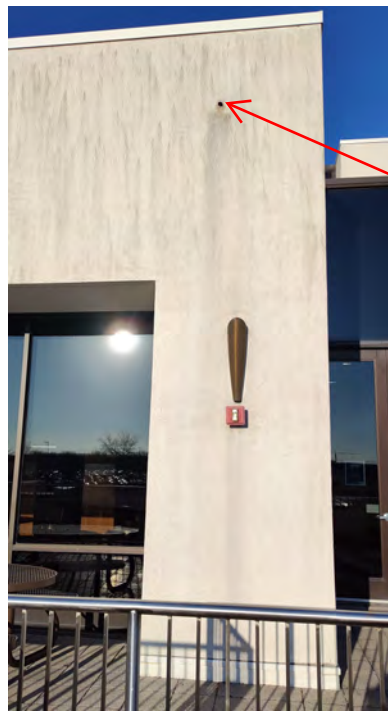
Picture "2B"

E.I.F.S FINISH IS DAMAGED WITH +/- 3" HOLE

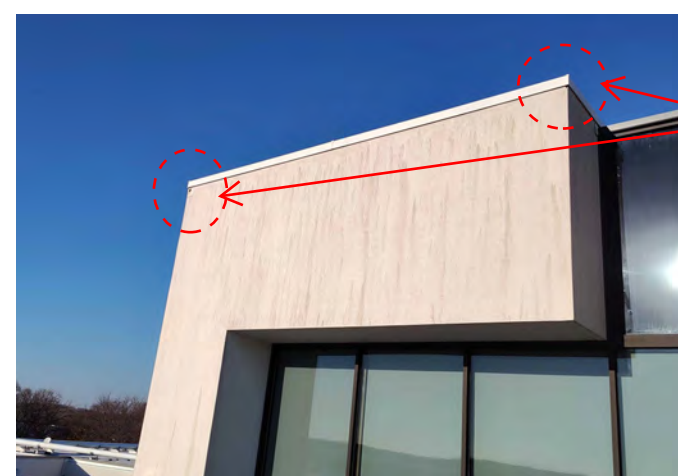
Picture "3A"

E.I.F.S. FINISH IS DAMAGED WITH +/- 3" HOLE

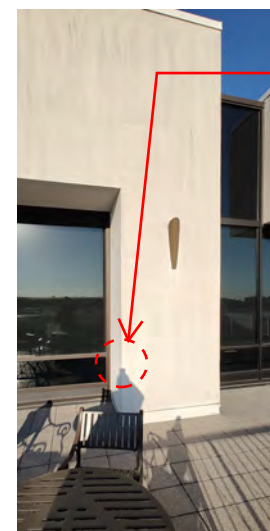
Picture "3C"

EDGE OF E.I.F.S. FINISH IS CHIPPED AT OUTSIDE CORNER

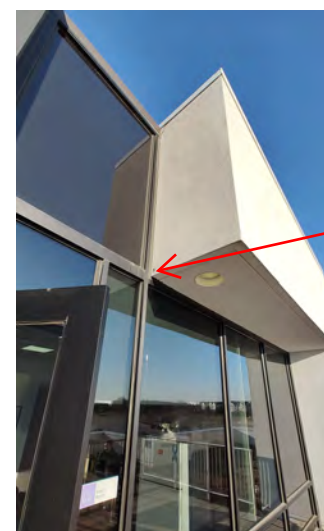
Picture "3E"

E.I.F.S. FINISH IS DENTED AT THIS LOCATION

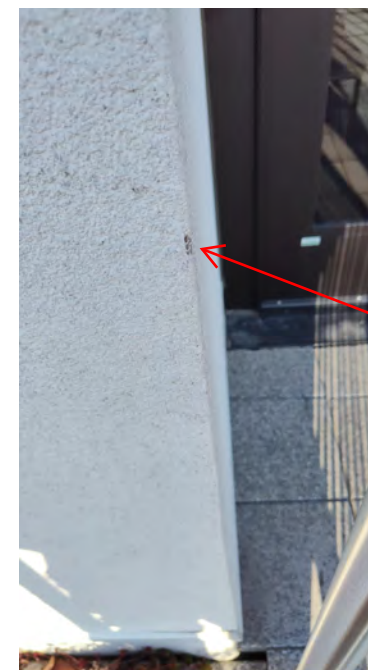
Picture "3B"

EDGE OF E.I.F.S. FINISH IS CHIPPED AT OUTSIDE CORNER

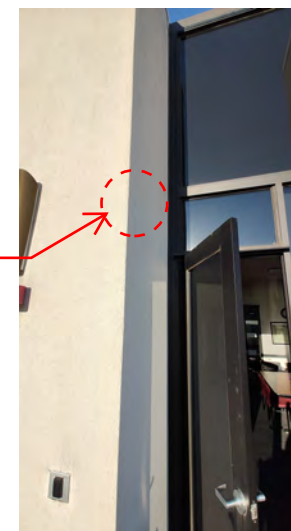
Picture "3D"

EDGE OF E.I.F.S. FINISH IS CHIPPED AT OUTSIDE CORNER

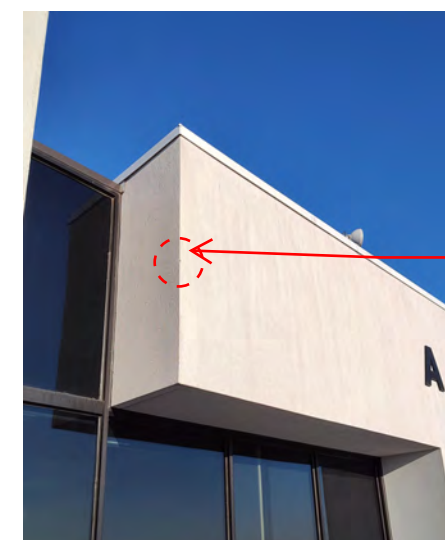
Picture "3F"

EDGE OF E.I.F.S. FINISH IS CHIPPED AT OUTSIDE CORNER
